THE ROLE OF BIOFILMS AND LICHENS IN THE PRESERVATION OF ARCHAEOLOGICAL FEATURES IN THE BANDELIER TUFF, BANDELIER NATIONAL MONUMENT

Case hardened surfaces that develop over tuff outcrops in Frijoles Canyon (Bandelier National Monument, New Mexico, USA) are a combination of biotic and abiotic crusts that contribute to the preservation of ancient anthropogenic features carved in the cliffs. This study shows that in the initial stages of crust development, lichens and other surface biota cement wind-blown and water-transported particles to the rock face and reinforce and stabilize the accumulated clay / silt coatings. Abiotic crusts form on canyon walls by the partial dissolution of the tuff in the near-surface zone, followed by precipitation of secondary minerals that form a durable cement. We conclude that acid excretions from cyanobacteria and lichens colonizing the surface act to catalyze tuff dissolution. The resulting case hardened surfaces are more erosion resistant than the underlying rock, and protect the fragile prehistoric rock-cut dwellings (cavates), features, and petroglyphs left by the ancient Pueblo people. In conducting the study, researchers have considered whether l

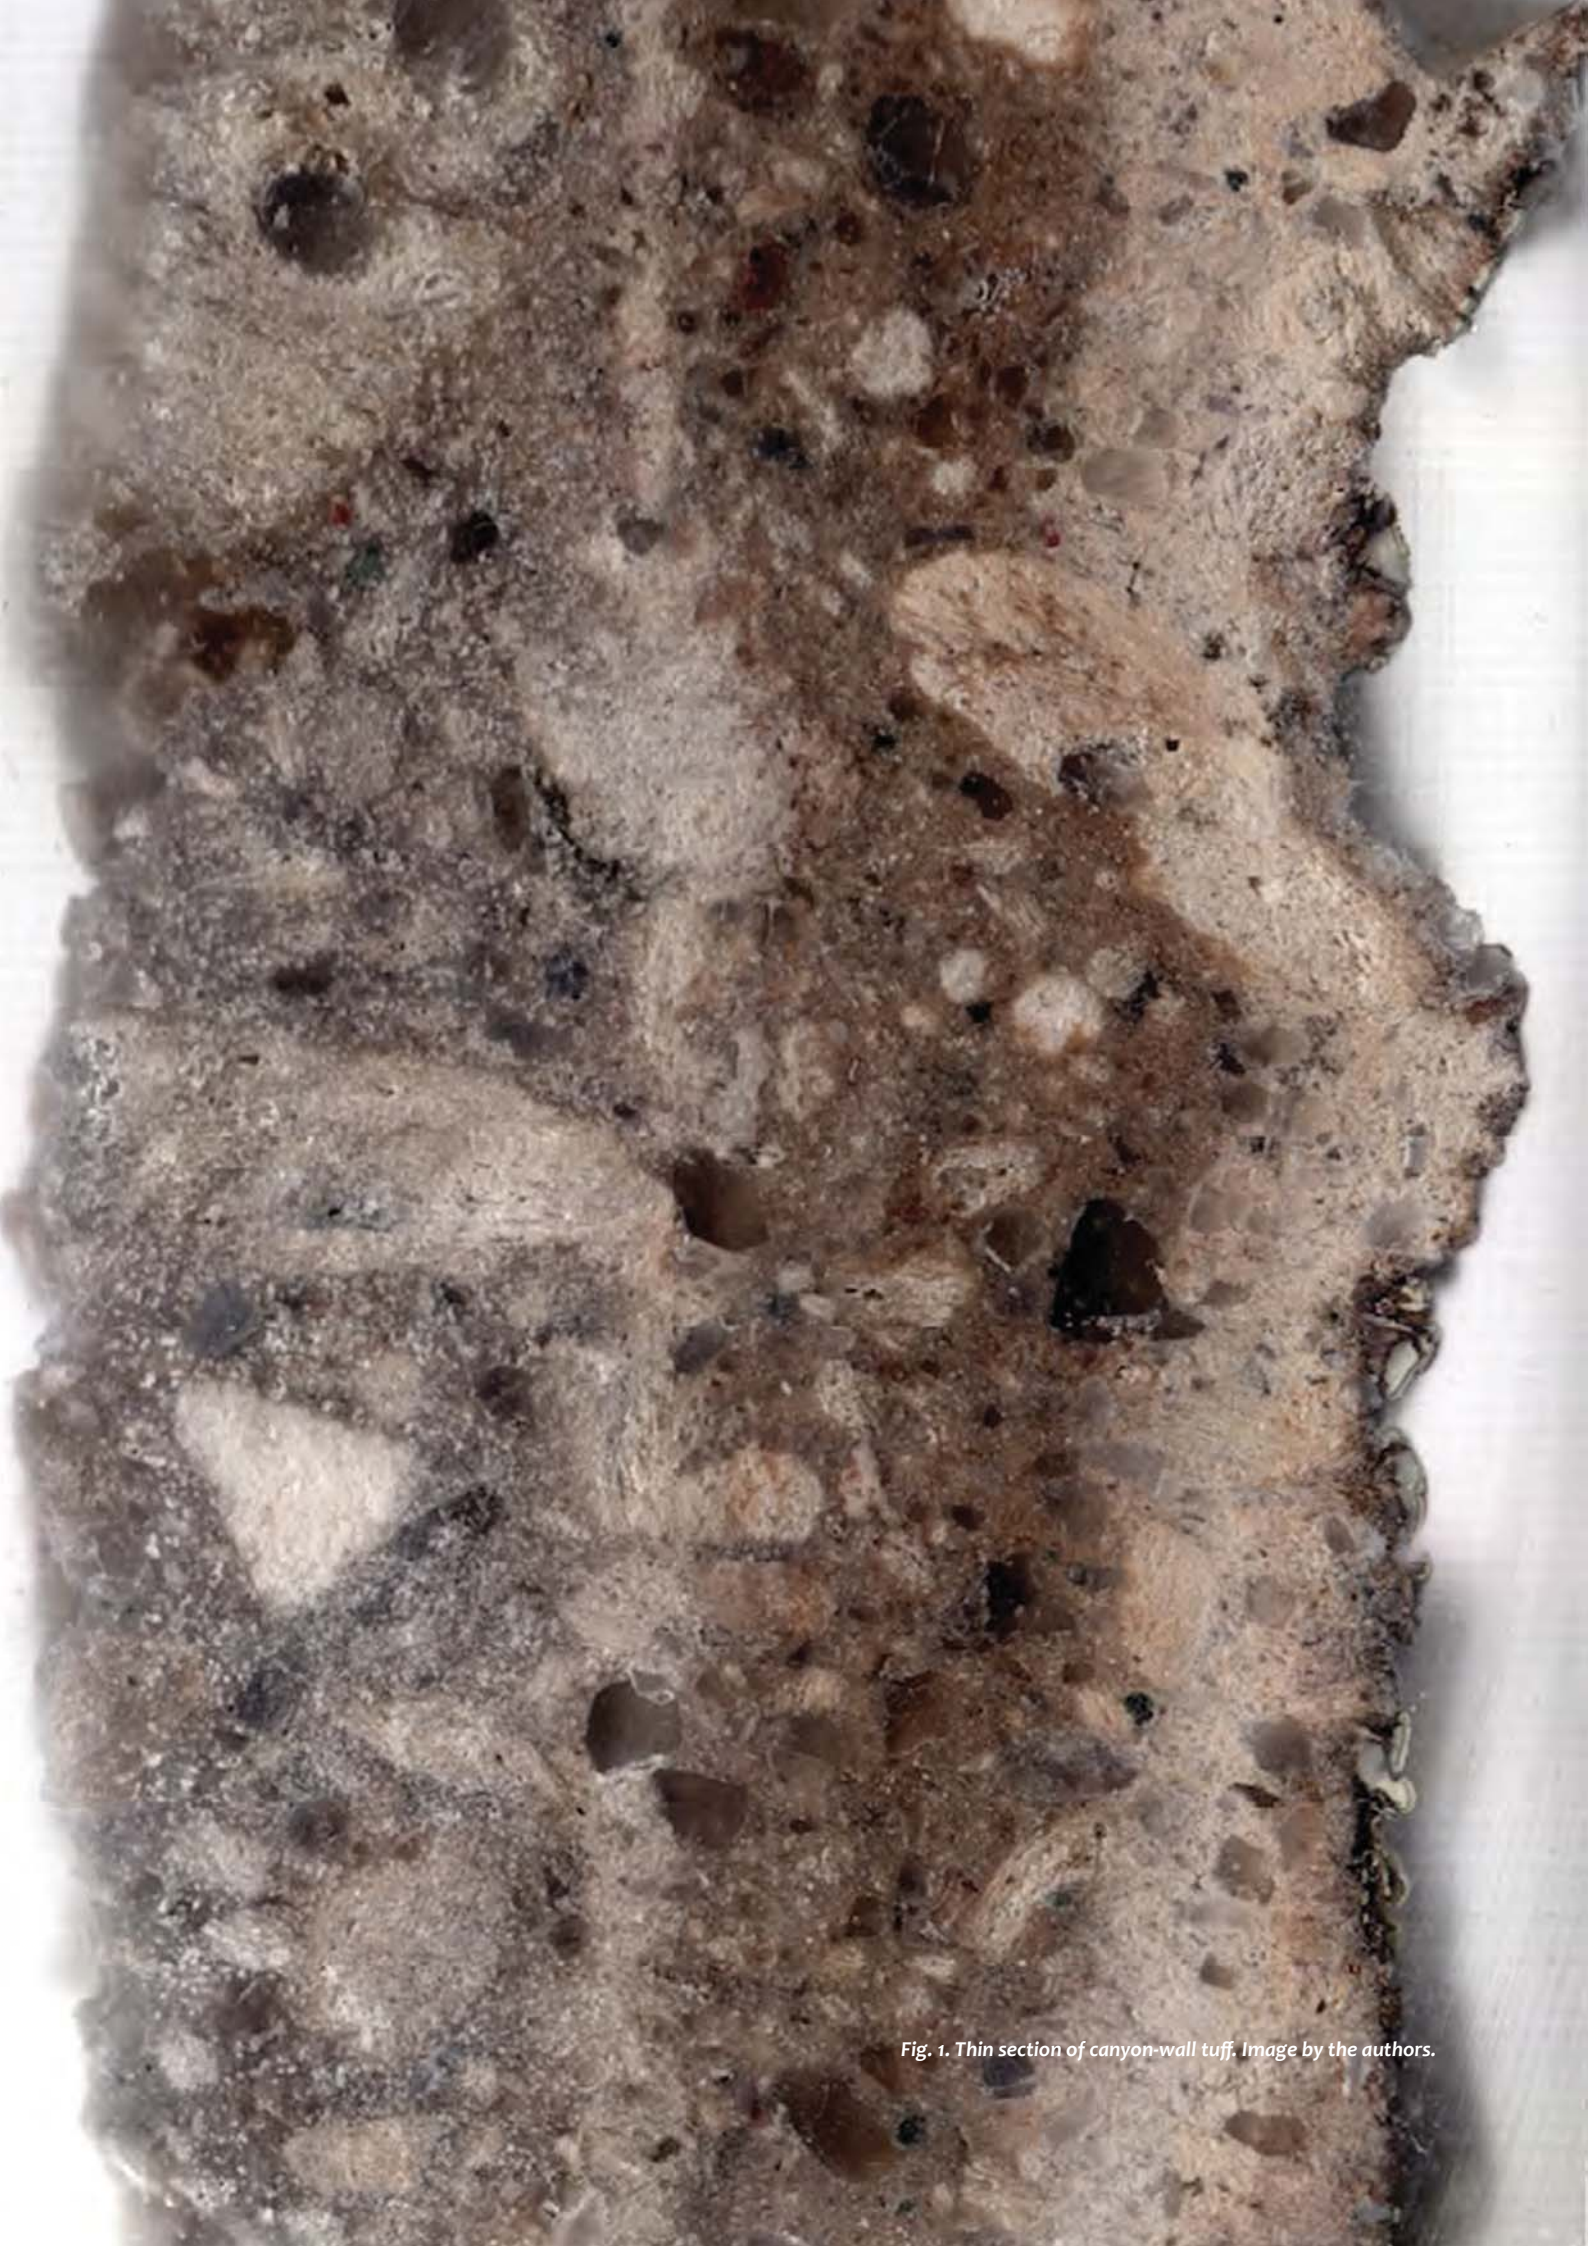
Fig. 1. Thin section of canyon-wall tuff. Image by the authors.

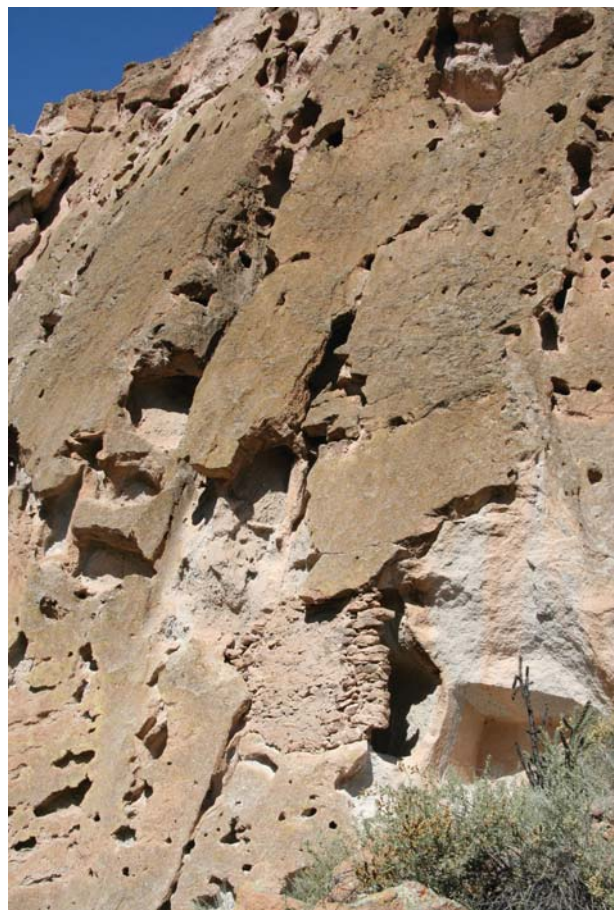
Fig. 5. Cavate Boo2 with its surviving masonry wall (bottom center). Note the broad range of case hardened surfaces of the surrounding tuff, and the "swiss-cheese" texture that develops where the durable case hardened surface is breached, exposing the soft underlying tuffs to erosion. The extensively altered surfaces (upper half) are types 6 and 7 (see Table 1); on the far right a more recently exposed surface, slightly recessed and having a smoother texture, has developed another rind. Areas of recent erosion appear as white or grey patches (Type 1); erosion at the lower right edge of the cavate threatens to undermine the prehistoric wall. Some of the freshly exposed tuff has begun to acquire silt-clay coatings (Type 2) that constitute one of the initial stages of case hardening. At bottom left, moderately well indurated surfaces have silt-clay layers colonized by lichens and other microflora (which appear yellow, green and black in the photo). Note the partially detached boulder above the wall, the column of cantilevered stones at the east end of the surviving wall, and the erosion of the tuff just below this column.

One challenge of conserving the cavates is how to preserve their physical integrity despite constant landscape-level change and erosion of the cliffs (Fig. 5). Deterioration processes affecting cavate condition include mass wasting of the cliff face through losses

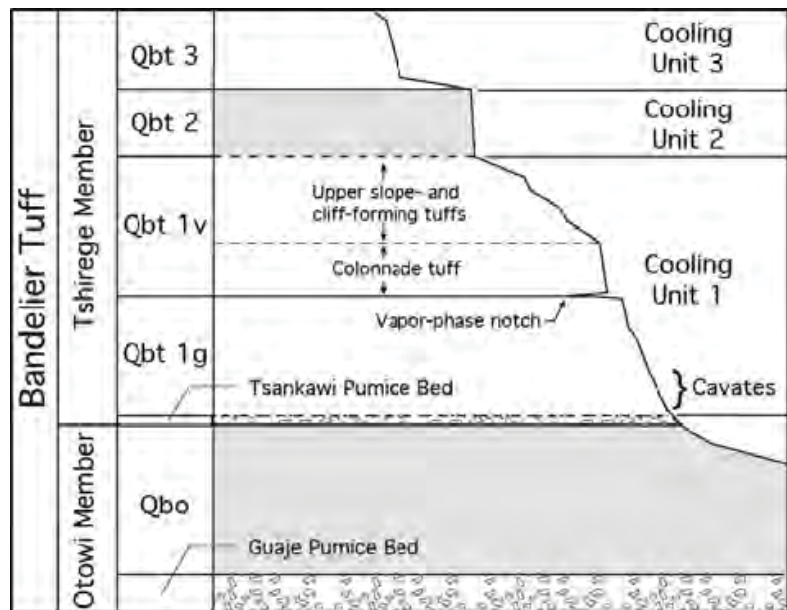
Fig. 6. Schematic stratigraphic column for the Bandelier Tuff showing subunits of the Tshirege Member in the ruins area of Frijoles Canyon.

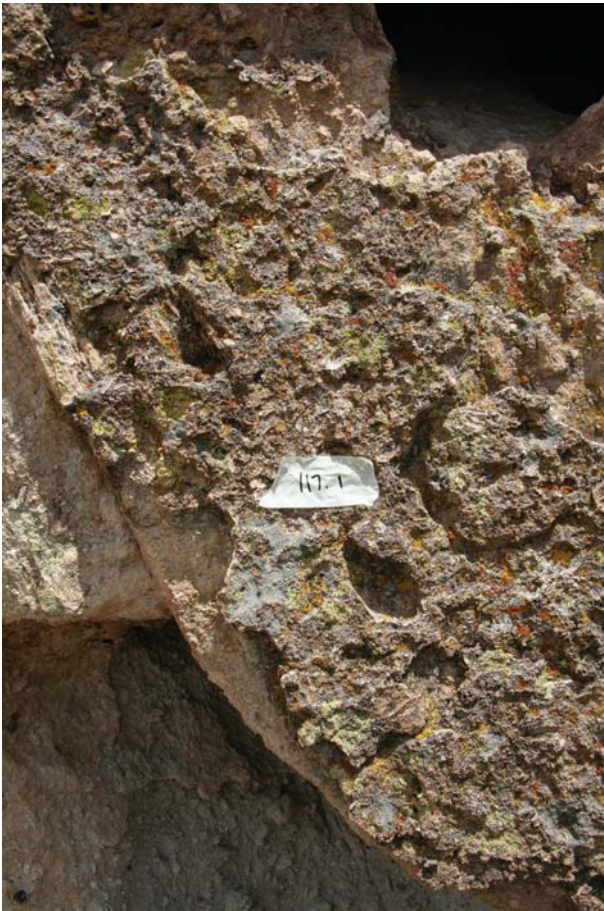
Fig. 7. Edge of an erosional remnant of a Type 7 case hardened surface showing a more recently exposed adjacent surface (left) that is less altered.

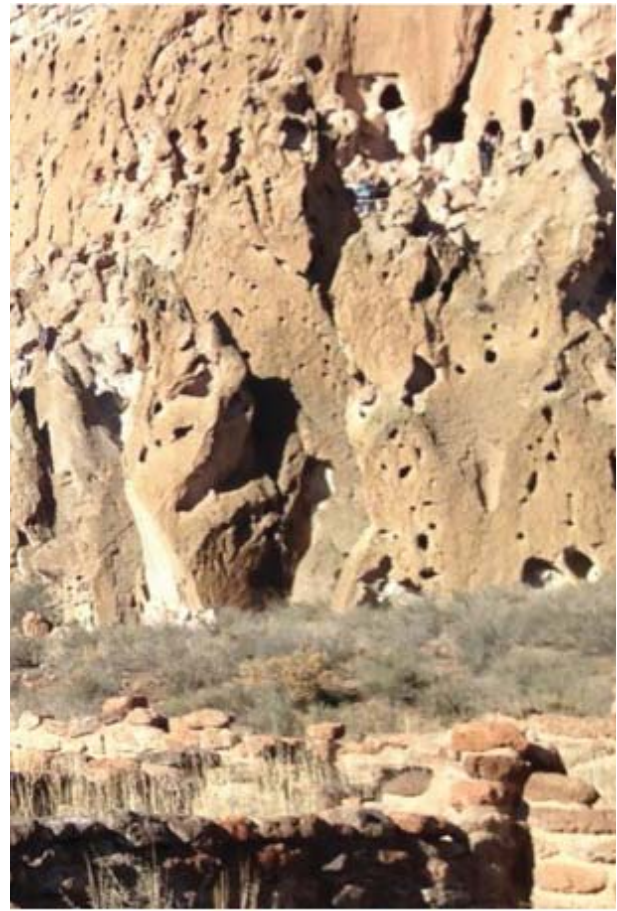
Fig. 8. Case hardened surfaces in unit Qbt 1g of the Tshirege Member of the Bandelier Tuff. 'Swiss-cheese' texture is characteristic where holes develop in the durable case hardened surface, exposing the soft underlying tuffs to preferential erosion by wind and water.

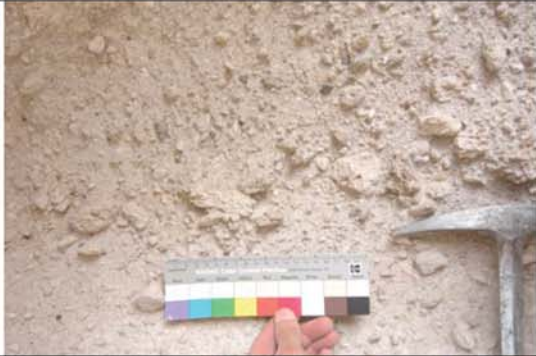
Type 1

<ul style="list-style-type: none"> • Freshly exposed, apparently unaltered tuff • White to light gray in color • Rough texture with prominent pumices • Little to no sedimentation of silt-clay or calcite visible on surface • Easily abraded with light pressure • Fine glassy ash in the tuff matrix is abundant and unaltered • Matrix porosity is high (40-50%) • Secondary minerals are absent to rare
Type 2

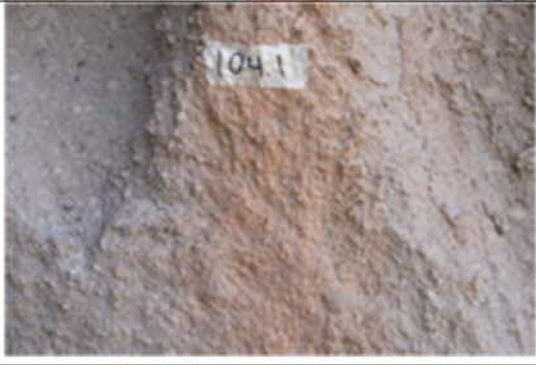
<ul style="list-style-type: none"> • Sedimented silt-clay coating over freshly exposed tuff • Coating is very thin, resembling a wash, and is often in runnels down the tuff surface • Filamentous cyanobacteria frequently found to have colonized this surface coating • Fine glassy ash in the tuff matrix is abundant and unaltered • Matrix porosity is high (40-50%) • Secondary minerals are absent to rare
Type 3

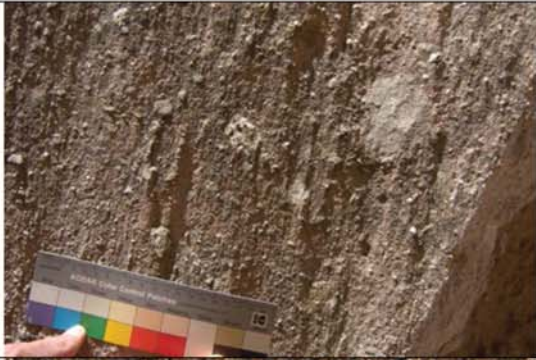
<ul style="list-style-type: none"> • Black biofilm layer overlaying exposed tuff • Silt-clay coating / lichen cover are less prominent surface features • Moderately indurated and resistant to erosion • Alteration is sporadic and generally limited to a zone 0.1 to 0.5 cm thick • Porosity remains high where the tuff is little altered, but in heavily mineralized areas is reduced to 20 to 30%

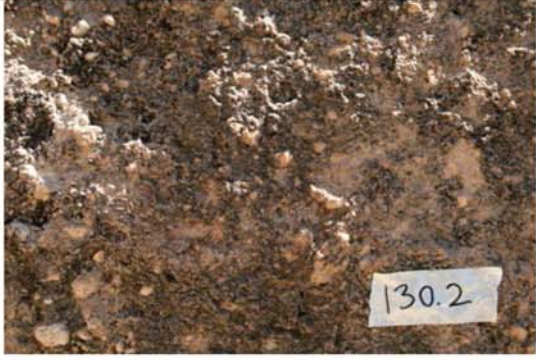
Type 4

<ul style="list-style-type: none"> • Lichens and other biogrowth appear over a prominent silt-clay coating • Crustose lichens are more plentiful than in other surface types • Moderately indurated and resistant to erosion • Alteration is sporadic and generally limited to a zone 0.1 to 0.5 cm thick • Porosity remains high where the tuff is little altered, but in heavily mineralized areas is reduced to 20 to 30%
Type 5

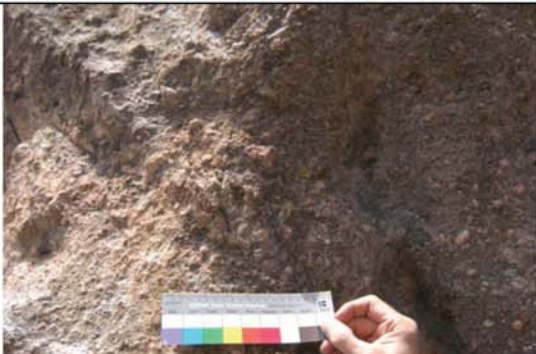
<ul style="list-style-type: none"> • Generous lichen distribution, often accompanying a thick silt-clay coating • Comparatively smooth texture, lacking the large surface asperities that are typical of Types 6 and 7 • Moderately indurated and resistant to erosion • Alteration is sporadic and generally limited to a zone 0.1 to 0.5 cm thick • Porosity remains high where the tuff is little altered, but in heavily mineralized areas is reduced to 20 to 30%

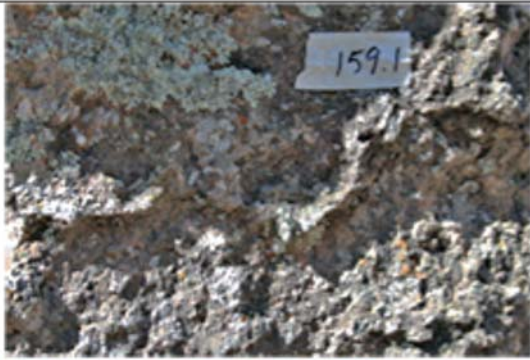
<p>Type 6</p>

<ul style="list-style-type: none"> • Well developed lichen growth • Surface is rough, with asperities in the range of 1-3cm • Abrupt changes in surface level at losses, with crust thickness of up to 4 cm • Strongly indurated, with crusts that are generally 1 to 1.3 cm thick • Case hardened zone is commonly made up of two parallel bands of alteration • Porosity for the inner alteration band commonly <5%
<p>Type 7</p>

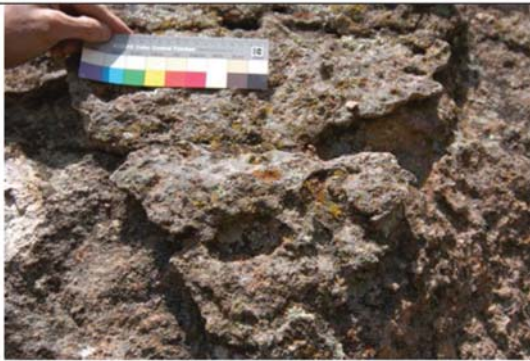
<ul style="list-style-type: none"> • Well developed lichen growth, with greater biocommunity diversity • Severely eroded, with surface asperities in the range of 1-6cm • Examples have prominent edges with crust thickness of up to 6 cm • Strongly indurated, with crusts that are generally 1 to 1.3 cm thick • Case hardened zone is commonly made up of two parallel bands of alteration • Porosity for the inner alteration band commonly <5%

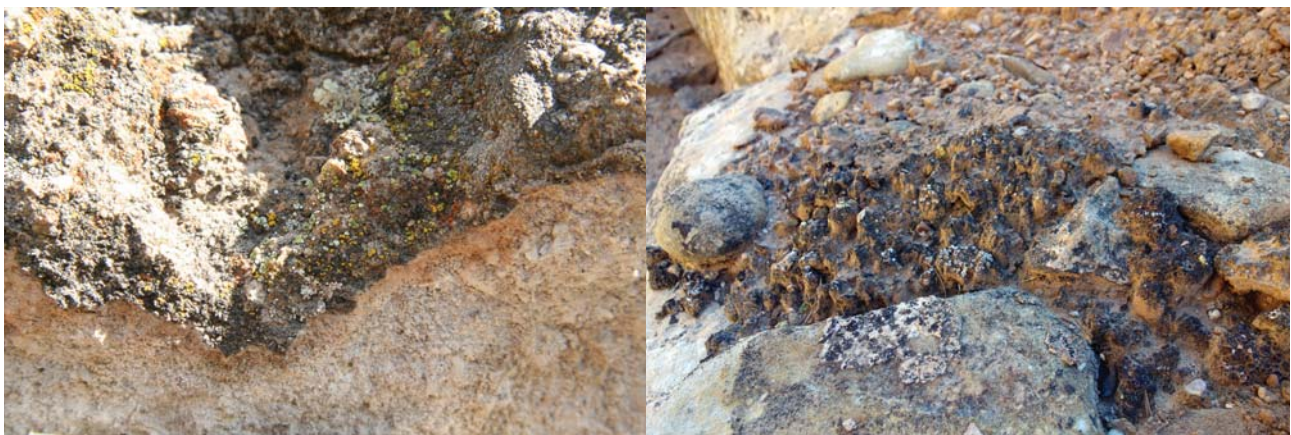
Fig. 9. The case hardened tuff surface (left) includes a silt-clay layer colonized by lichens. Note the similarities in surface topography and patina to the biological soil crust on the right.

Modification of canyon wall surfaces and development of a hard surface coating or rind (case hardening) involves three main components. 1) deposition of sedimented particulates on exposed tuff surfaces; 2) growth of lichens and microflora on (and in) exposed tuff surfaces and on the sedimented layers that coat them; and 3) bio-geochemical reactions that lead to the dissolution of volcanic glass and precipitation of secondary minerals (Fig. 9).

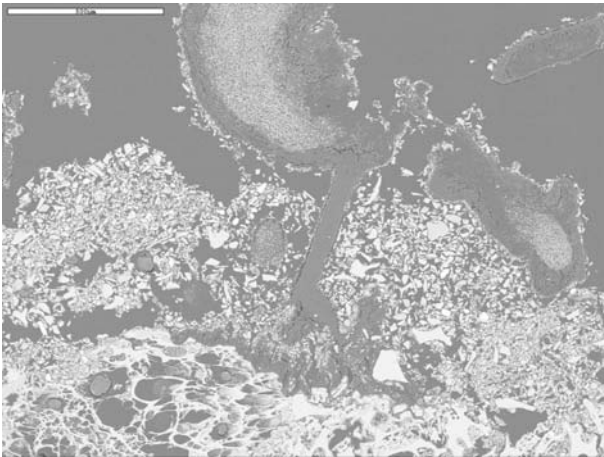
Fig. 10. SEM backscatter image showing a lichen thallus on sedimented volcanic ash adhering to the canyon wall. The lichen is the dark mass at the top. The sedimented layer (middle zone) is over 500 μm thick and includes shards, ash, and crystal fragments embedded in a clay matrix. Lichen rhizines / hyphae (microfilaments) pervade the sedimented layer and help stabilize it. The canyon wall bedrock is the area with the large pumice at the bottom.

Lichens are found on most tuff surfaces³ and their abundance and diversity appear to increase along with the degree of case hardening. SEM images show that lichens grow on top of the sedimented layers (Fig. 10) as

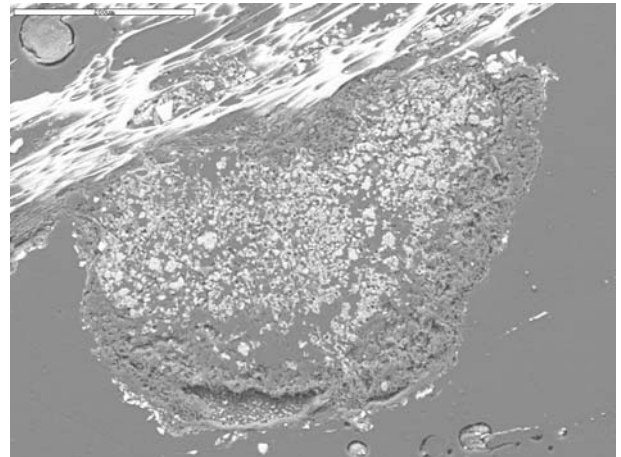
Fig. 11. SEM backscatter image showing a lichen thallus growing directly on tuff on the canyon wall. The lichen is the dark mass with the cellular structure. Light gray crystals of weddellite (calcium oxalate) fill the thallus. Microfilaments invade the long-tube pumice vesicles of the bedrock tuff at the top of the photograph.

well as on bare bedrock surfaces (Fig. 11). In the Qbt 1g subunit, lichens and other biotic crust constituents help stabilize canyon walls by acting as a protective buffer between the tuffs and wind and surface water erosion and they trap wind-blown and water-transported silt particles within their overlapping lobes. Secretions of sticky polysaccharides enhance cementation of the friable materials found at the substrate surface⁴. Lichen rhizines form a dense network of filaments that invade, reinforce, and stabilize the sedimented layers and the open intergranular pores and pumice vesicles of the bedrock tuff (Fig. 12); in the samples examined for this study, microfungal filaments were found to extend up to 1 mm into the tuff bedrock. Oxalic acid excreted by biotic constituents plays a role in the dissolution of volcanic glass. The role of lichens as a source of oxalic acid is demonstrated by dense accumulations of 1 to 3 μm oxalate crystals in lichen thalli. These crystals are identified as weddellite ($\text{CaC}_2\text{O}_4 \cdot 2\text{H}_2\text{O}$) based on their tabular form and SEM EDS analyses. Glass dissolution at the thallus-substrate interface is manifested as scalloped and embayed edges on glass shards and pumice lapilli (Fig. 13).

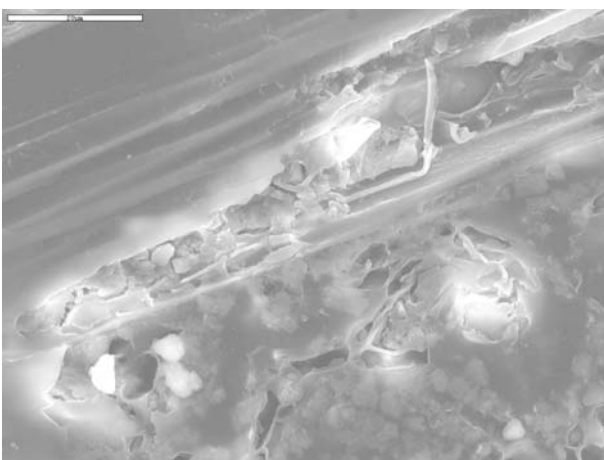
Fig. 12. SEM secondary electron image showing dissolution of pumice vesicle walls in contact with lichen hyphae. The tubular pumice (extending from lower left to upper right) has scalloped edges. Lichen (lower right) is in contact with the pumice and hyphal filaments invade the large open vesicle (upper right).

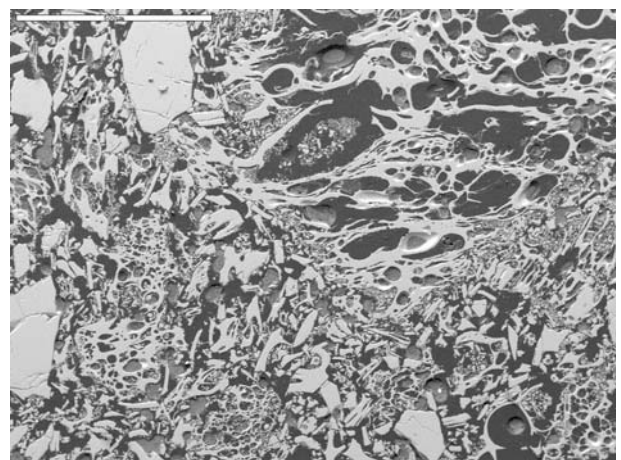
Fig. 13. SEM backscatter image of canyon wall tuff bedrock with Type 1 to 2 alteration. The tuff has undergone minimal alteration and lacks cementation by secondary minerals. The tuff contains abundant vitric ash in the groundmass, and delicate shard and pumice lapilli structures are well preserved. The porosity of the tuff is 40 to 50%.

tuffs show little or no evidence for glass dissolution and secondary minerals cementing the soft tuff matrix are rare to absent (Fig. 13). In one sample, small amounts of intergrown opal ($\text{SiO}_2 \cdot n\text{H}_2\text{O}$) and smectite group minerals $(\text{Na,Ca})_{0.33}(\text{Al,Mg})_2(\text{Si}_4\text{O}_{10})(\text{OH})_2 \cdot 4\text{H}_2\text{O}$ are deposited in pores near the outer wall surface, but most of the sample is free of alteration. Important characteristics of Type 1 and 2 surfaces are: 1) fine glassy ash in the tuff matrix is abundant and unaltered; 2) the matrix porosity is high (40-50%); 3) secondary minerals are absent to rare; and 4) exposed tuff surfaces are soft and friable because of the lack of cementation.

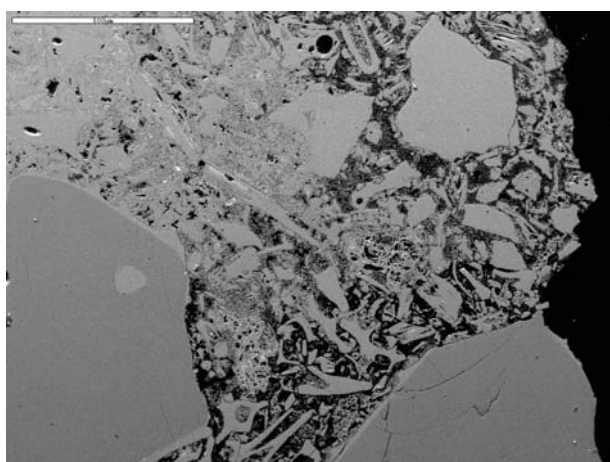
Fig. 14. SEM backscatter image of case hardened tuff with Type 3 to 5 alteration. At the sample surface (right), the larger glass shards are moderately scalloped and unfilled pore spaces still account for 30-40% of the sample volume. Moving left, there is more dissolution and replacement of the original material and pore space is reduced to < 20%. Opal is the dominant filling material; other filling materials include sepiolite and intergrown calcite and opal (4-4). At the far left, open pore space is less than 5% at a depth of approx. 1.30mm.

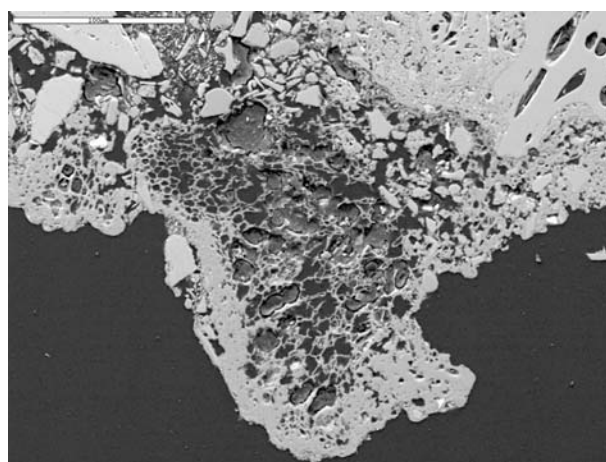
Fig. 15. SEM backscatter image showing pseudomorph of a lichen replaced by opal in a case-hardened surface; delicate cellular structure of lichen is preserved by the mineralization. The lichen is attached to tuff bedrock where most of the fine ash in the matrix is replaced by intergrown opal and clay. Small bright white areas are trace barite.

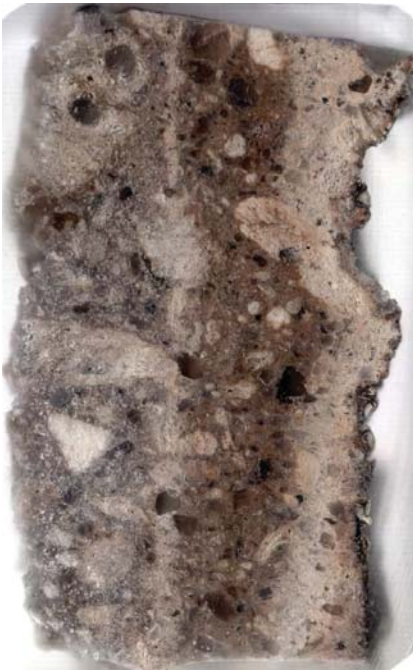
Fig. 16. Canyon-wall tuff with Type 7 alteration. The image is a thin section butt 2.5 cm wide cut perpendicular to the canyon wall. The canyon wall is on the right side of the image. The case hardened zone is made up of two parallel bands of alteration. The outer alteration band, next to the canyon wall, is mostly white in color. The inner alteration band ranges is medium to dark brown in color. Both bands are extensively altered, but the inner band is more highly mineralized. The tuff left of the inner band of alteration is slightly altered and contains abundant volcanic glass. Porosity is 20 to 30% in the outer band, 1 to 15% in the inner band, and 30 to 40% in the slightly altered tuff.

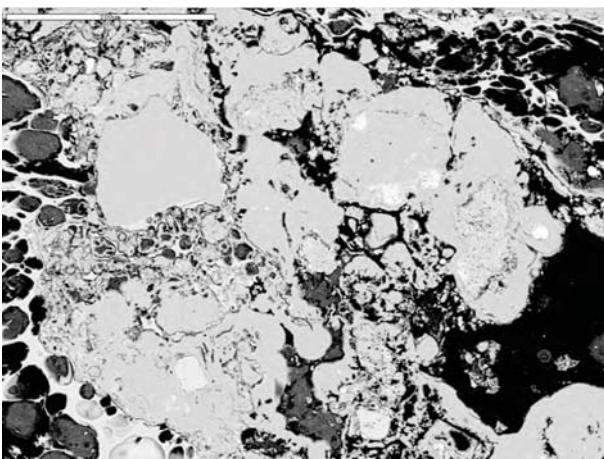
Fig. 17. SEM backscatter image for the outer band of alteration in Type 7 case hardened tuff. Volcanic ash in the tuff matrix is replaced by thick, massive bands of opal (medium gray) and finely intergrown opal and clays (mottled appearance). Some larger glassy pyroclasts (vesicular pumice and 100- μm -wide equant clast in the upper left quadrant) survived alteration, but show moderate to severe effects of dissolution at their margins. There are thin rinds of opal pseudomorphs replacing pumice vesicles in the center left part of the image.

Canyon walls with Type 6 and 7 surfaces (Table 1 and Fig. 6) are strongly indurated and form the most erosion-resistant cliff faces in unit Qbt 1g. These surfaces are extremely rough and support extensive biocommunities. Case hardened surfaces form crusts that are generally 1 to 1.3 cm thick, but pockets of alteration extend as much as 2.5 cm from the canyon wall. The case hardened zone is commonly made up of two parallel bands of alteration (Fig. 15). The outer alteration band, next to the canyon wall, is 3.5-6.7 mm thick and is mostly white in color. The inner alteration band ranges 5 to 8.5 mm thick and is medium to dark brown in color. The transition between the two zones is abrupt, occurring over a distance of 0.1 mm or less. The outer band is extensively altered, and is characterized by replacement of the ashy tuff matrix by opal that envelops glass shards and pumice lapilli (Fig. 17). The edges of shards and pumice lapilli show moderate to

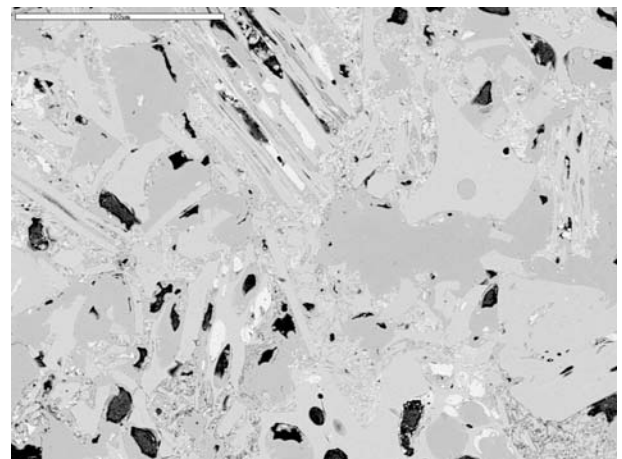
Fig. 18. SEM backscatter image for the inner band of alteration in Type 7 case hardened tuff. Large glassy shards (light gray) show few delicate cusped structures due to dissolution. The shards are thoroughly cemented by massive opal (medium gray), calcite (white), and sepiolite (small mottled dark gray areas). All of the fine matrix ash and most of the original pore space have been replaced by mineralization. The few remaining pores are shown in black. Image analysis of this image yields the following proportions: 49.2% glass shards, 43% opal, 4.3% calcite, trace sepiolite, and 3.5% porosity.

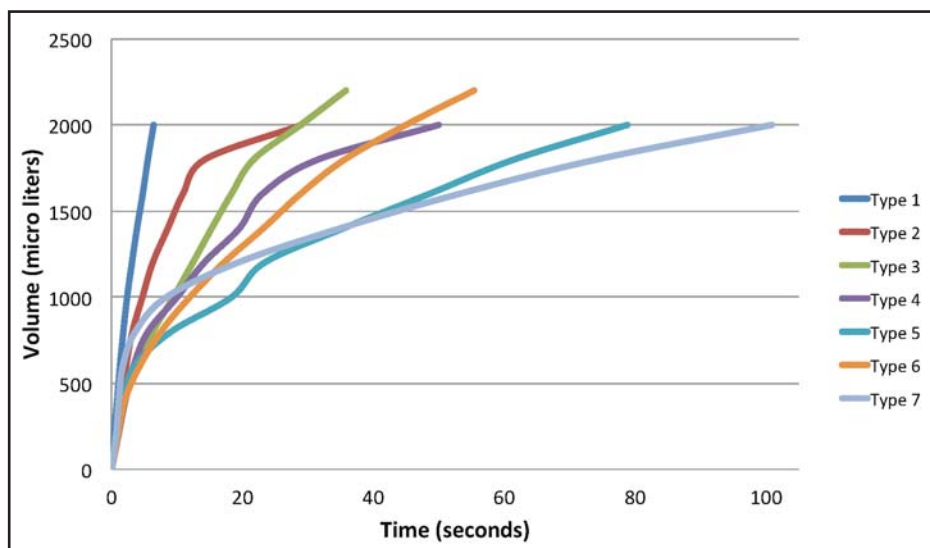
Table 2. Absorption values for each surface type are plotted against time. For Type 1 surfaces the average rate is essentially linear, while for Types 2-7 rates slowed significantly as the experiment progressed.

tuff surfaces were greater than for samples having more highly developed crusts. Rates for unaltered surfaces (Type 1) were essentially linear. For altered surfaces, absorption rates slowed as the experiment progressed; this suggests that the swelling of clays or mucilaginous films may play a role in reducing absorption for crusts in initial stages of development (Types 2-4), while for well-developed crusts with occluded pores, there appears to be initial filling of the available porosity followed by leveling off of the absorption rate (Table 2).

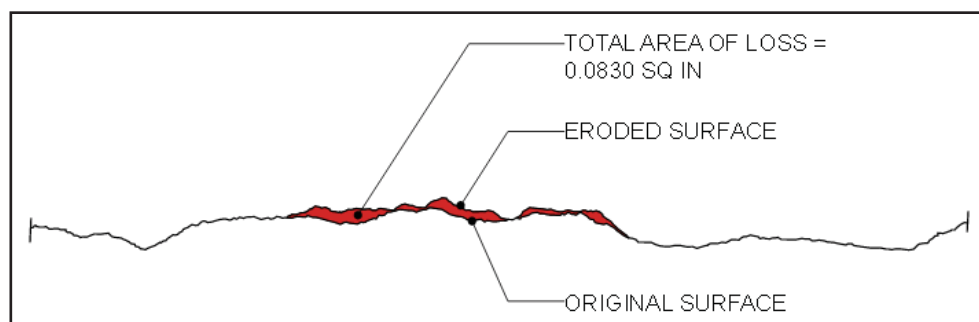
Fig. 19. Sample profile. Image by the authors.

Table 3. Erosion was measured as the area between surface profiles collected before and after each test (Fig. 19), and average erosion areas were plotted for each surface type.

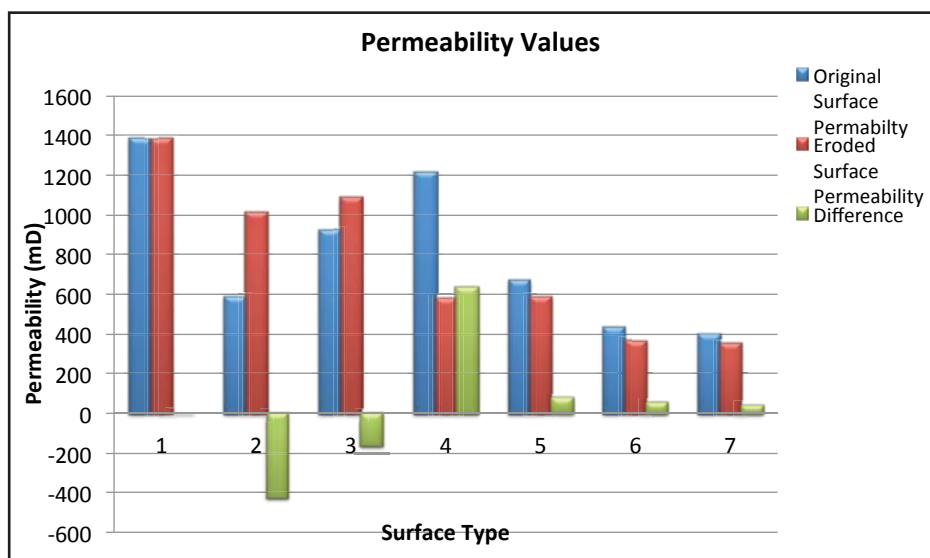
Table 4. Surface permeability values were collected for each sample with the sample surface intact. A second set of values was collected after eroding sample surfaces to remove sediments and biological material.
